Libby Asbestos Superfund Site
The Former Screening Plant and Surrounding Properties,
Operable Unit 2
Lincoln County, Montana

Final Remedial Action Report

USACE Contract No. W9128F-11-D-0023

April 20, 2012

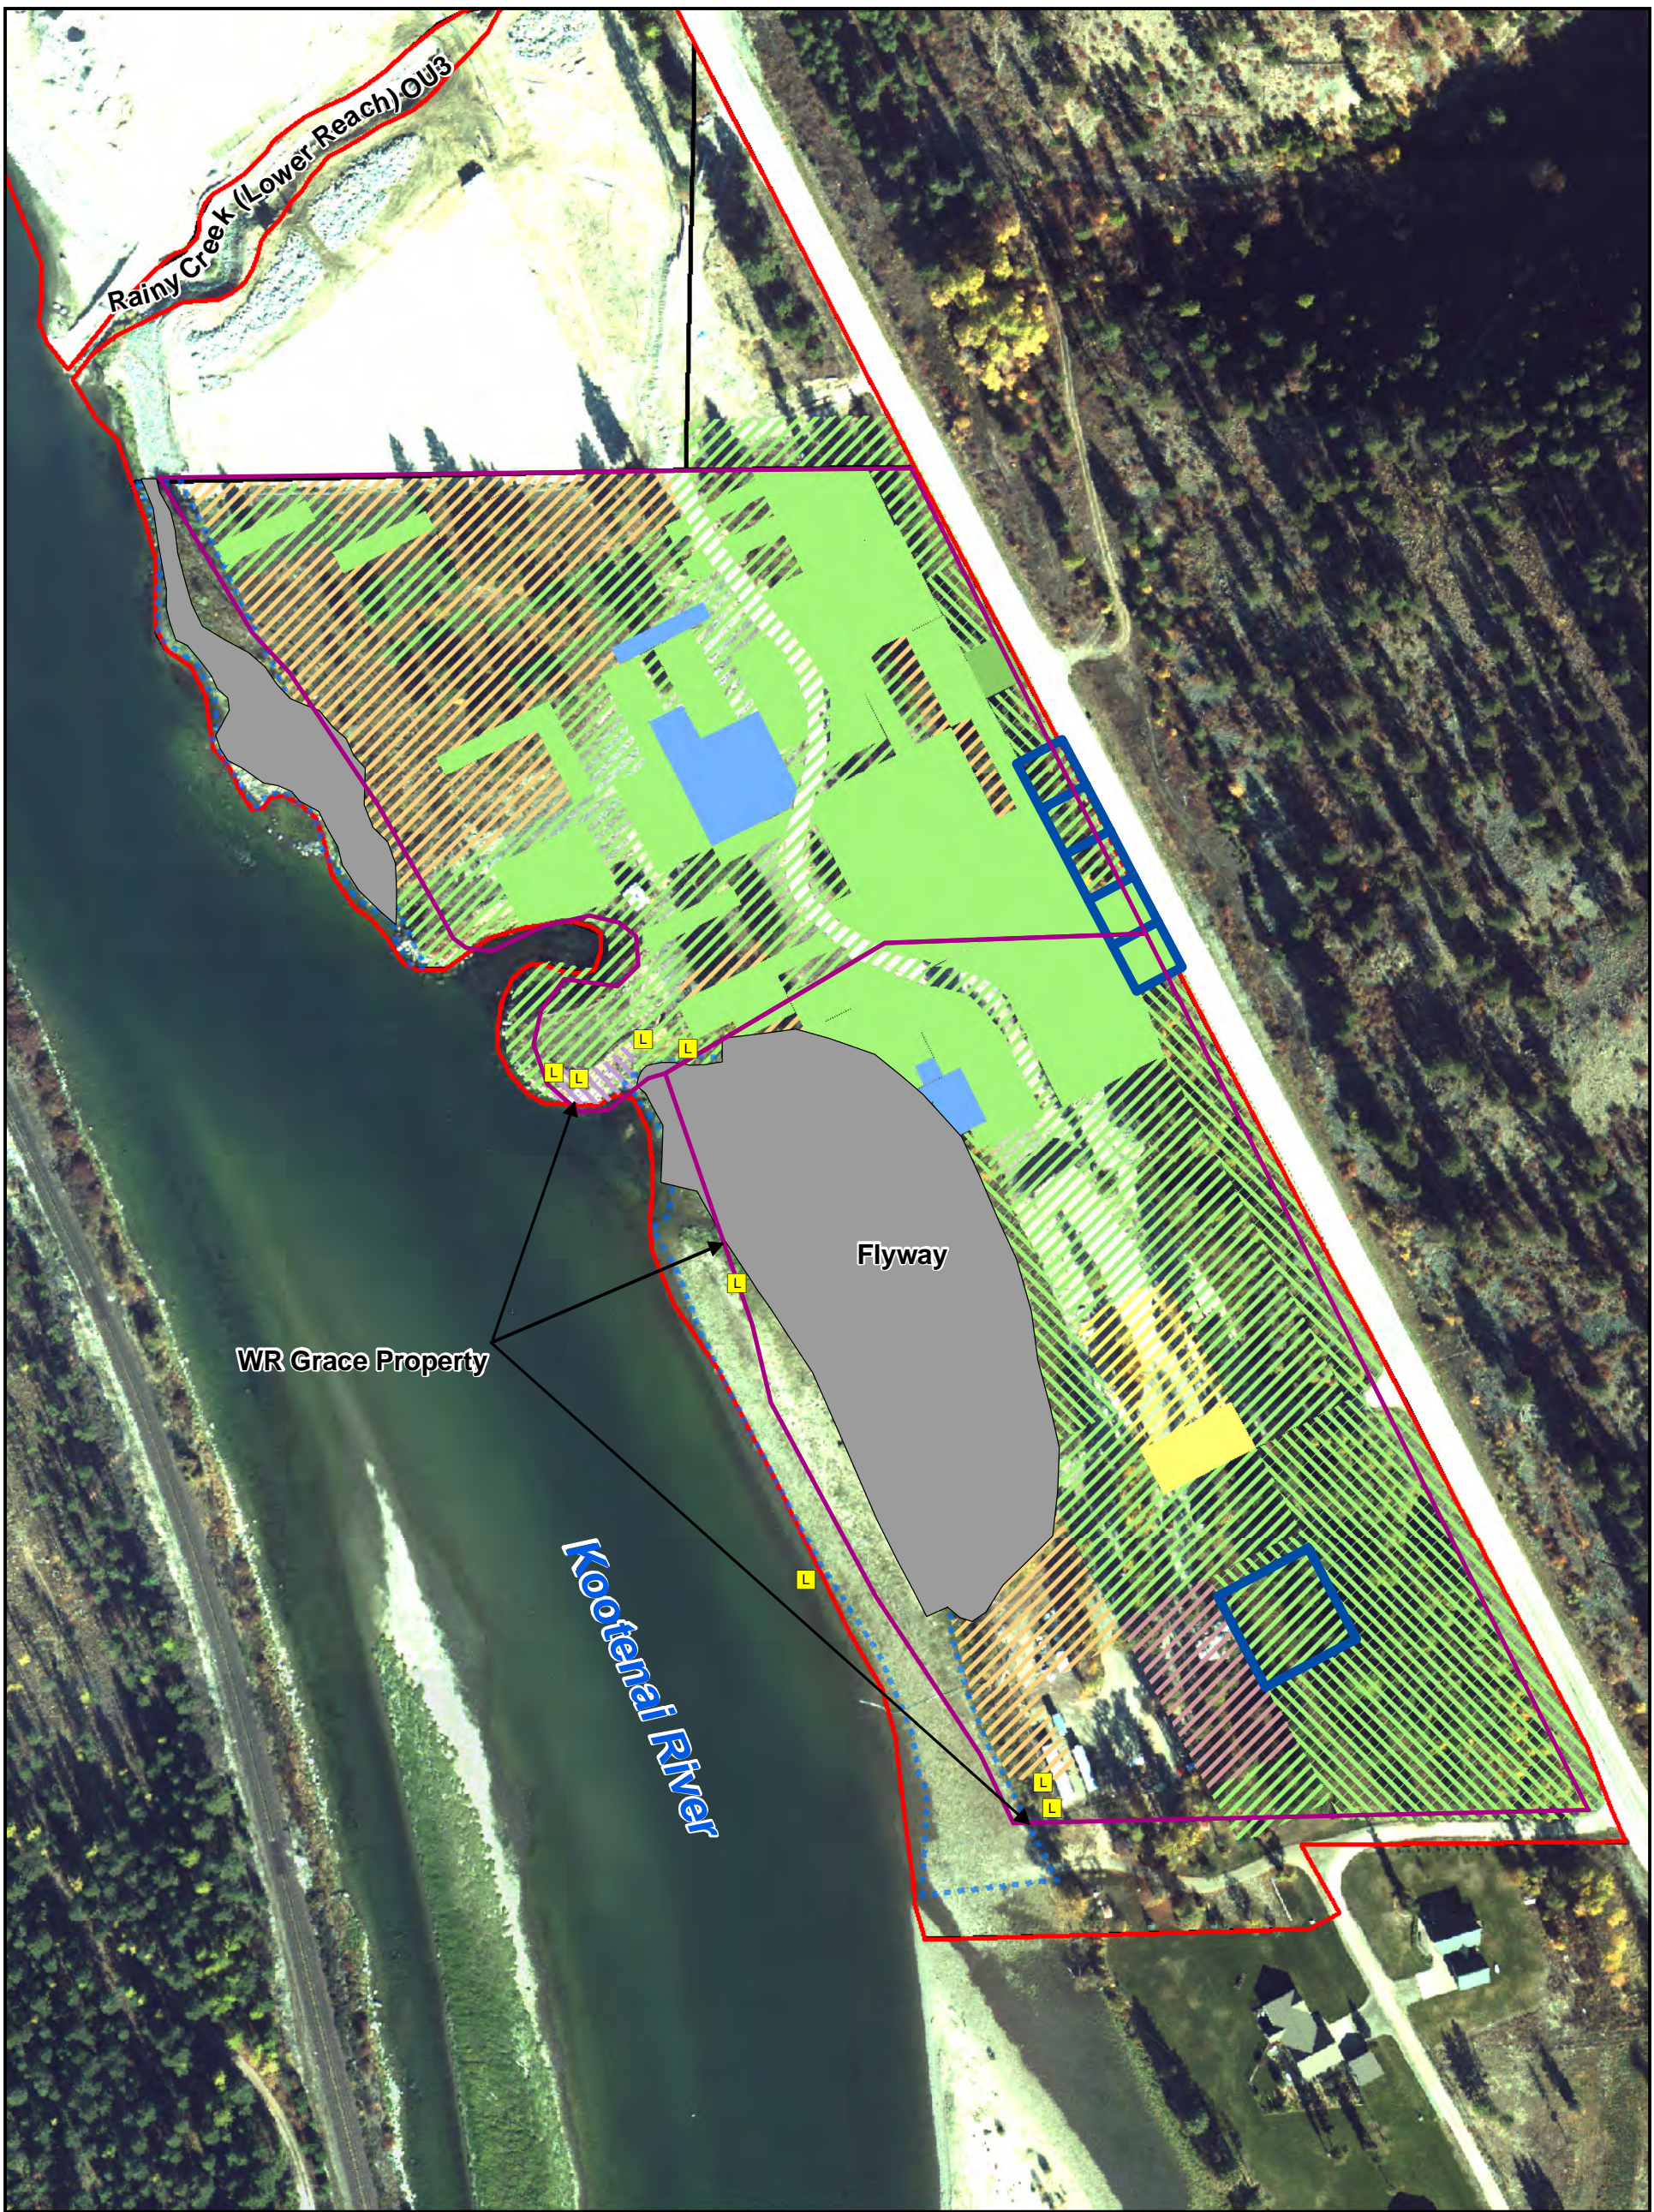
Figure 2-3
 Location and Depth of Residual Contamination
 at OU2 - WR Grace Property Based on
 Investigation Activities and Removal-related
 Confirmation Soil Sampling
 Libby Asbestos Superfund Site
 Lincoln County, Montana

- Figure 2-3 of the Final RI Report (EPA 2009b) indicates that residual LA contamination may be found at depths greater than 4 feet bgs over a large portion of the former Screening Plant (Subarea 1). Some of this area was excavated and restored with clean fill to a depth greater than 5 feet. Note that in the memorandum the clean fill depth was incorrectly reported as 4 feet. The EPA directed CDM Smith to produce a new figure based on RI Figure 2-3 that identifies areas where residual LA contamination may be found at depths greater than 5 feet below existing grade.

- Figure 2-3 of the Final RI Report (EPA 2009b) identifies four areas within the former Screening Plant (Subarea 1) where residual contamination may be found at less than 1 foot bgs. To confirm that a minimum of 12 inches of clean fill exists over any potential residual LA contamination, the EPA and MDEQ agreed that each of these areas should be sampled as soon as possible.

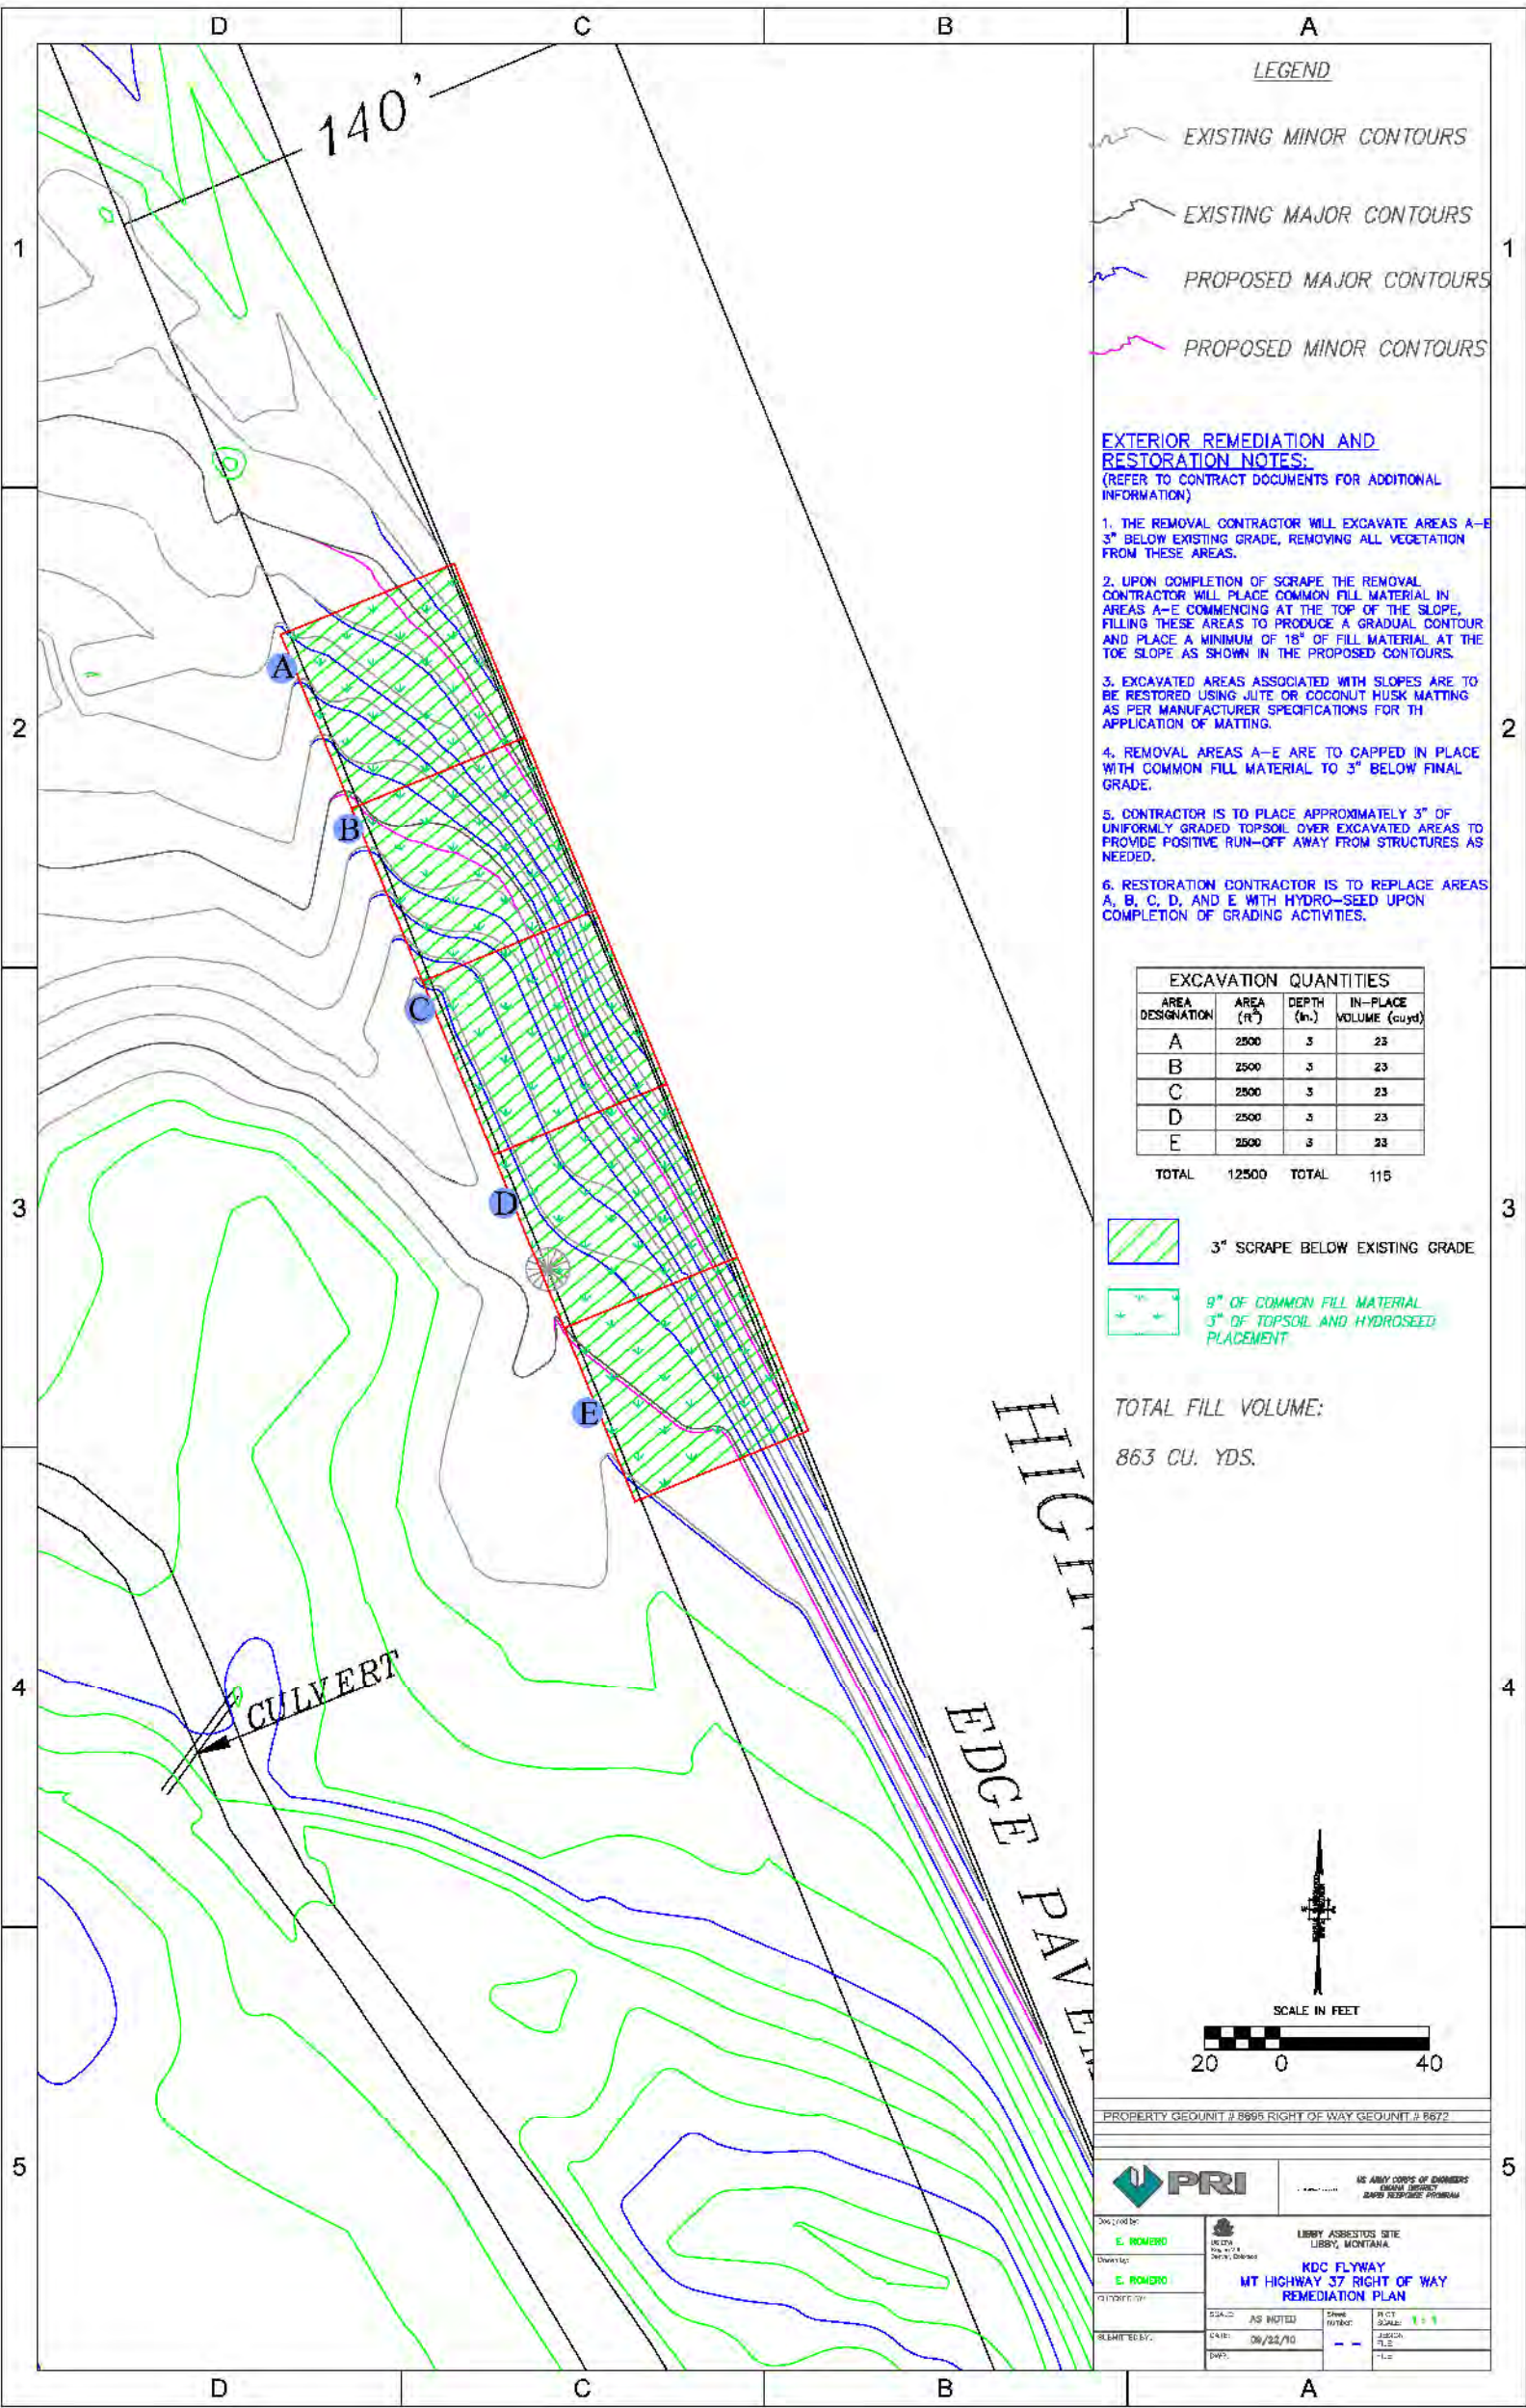
Figure 3-1
Remediation Design
KDC Flyway: MT Highway 37 Right of Way
Libby Asbestos Superfund Site
Lincoln County, Montana

The ROD required that excavation continue until source material was removed (to a maximum depth of 3 feet) and if contamination continued below 3 feet, that a visible marker layer be placed prior to backfill. Excavation in the Highway 37 ROW was limited to a depth of 6 inches due to highway structural integrity concerns, so contamination could not be removed beyond this depth. The EPA determined that the marker layer was not necessary in the ROW because confirmation soil samples contained low concentrations of LA and minor amounts of visible vermiculite were observed on the floor of the excavation.

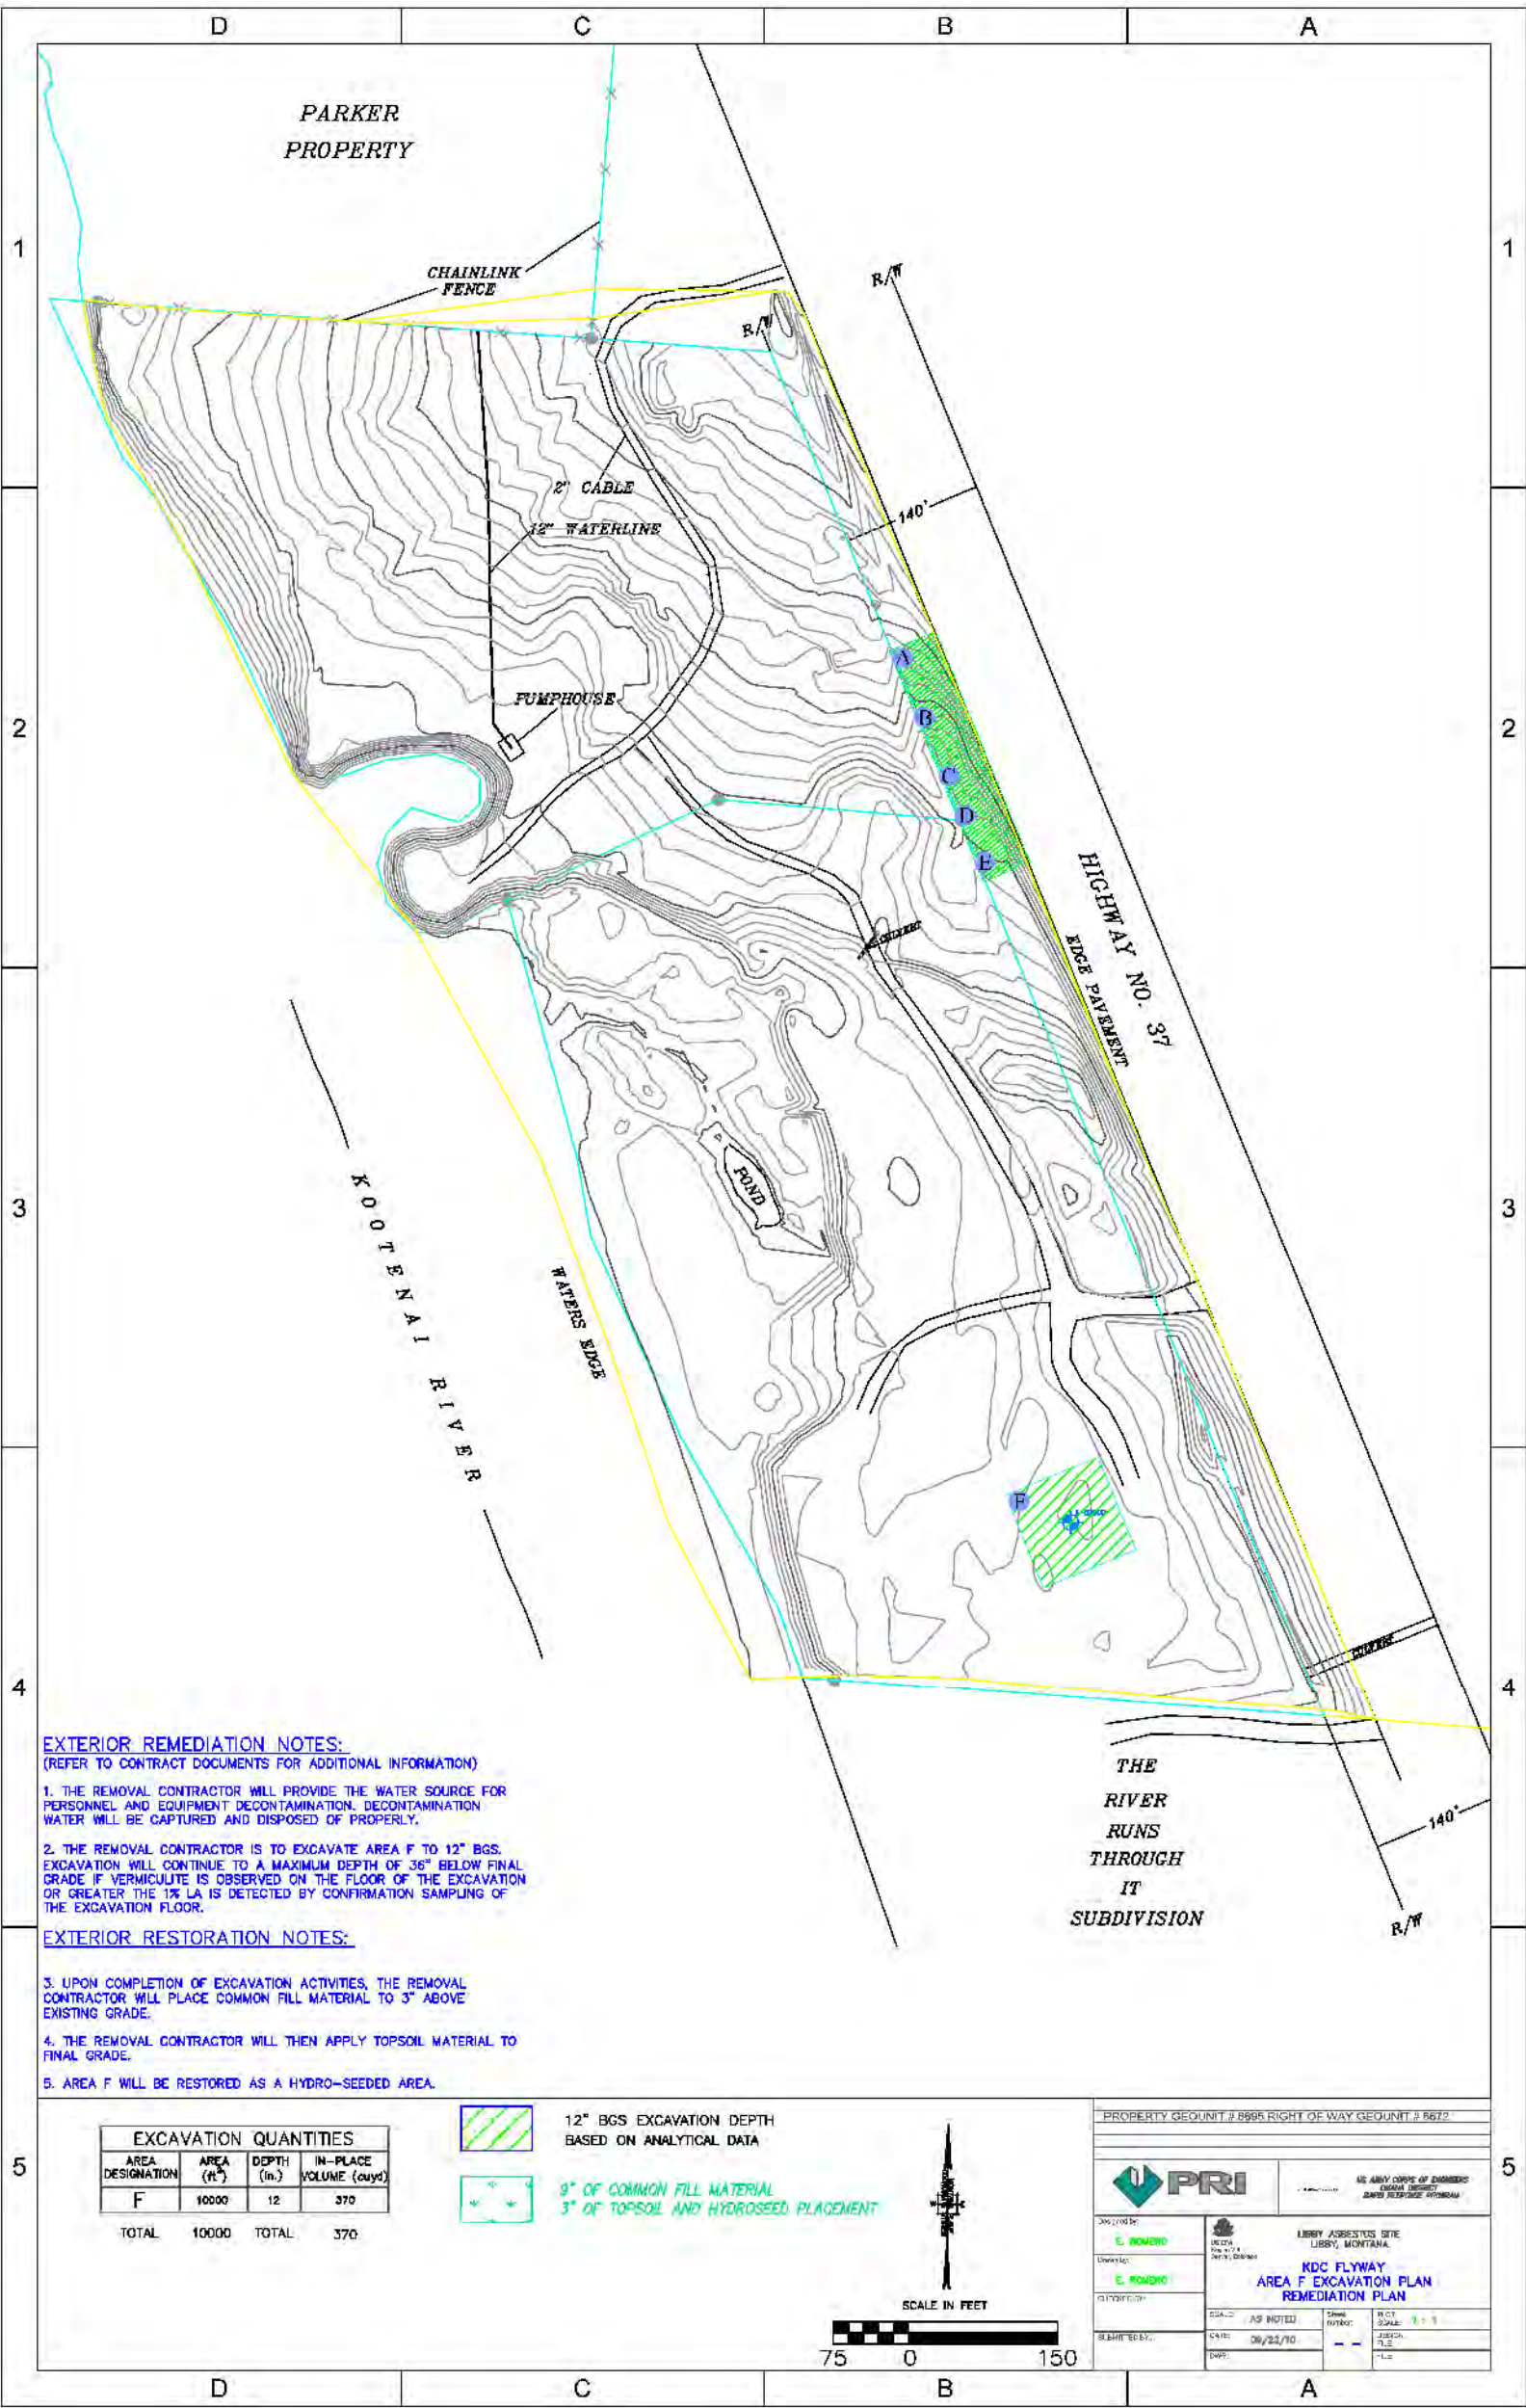
Figure 3-2
Remediation Design
KDC Flyway: Area F
Libby Asbestos Superfund Site
Lincoln County, Montana

A visible marker layer was not placed at the bottom of the excavation prior to backfill. The marker layer was not necessary in Area F because all confirmation soil samples were ND for LA and no visible vermiculite was observed at the bottom of the excavation. The EPA determined that the marker layer was not necessary in Areas A through E because confirmation soil samples contained low concentrations of LA and minor amounts of visible vermiculite.

Area F was backfilled with 9 inches of common fill, placed and compacted in 3- to 6-inch lifts, followed by an additional 3 inches of topsoil. Restoration of Area F began on September 29 and was completed on October 4, 2010. It should be noted that the dates on the Property Closeout Checklists (PCCs) reflect both the ROW and Flyway excavation and restoration. The more specific dates provided in this section are taken from QARs.

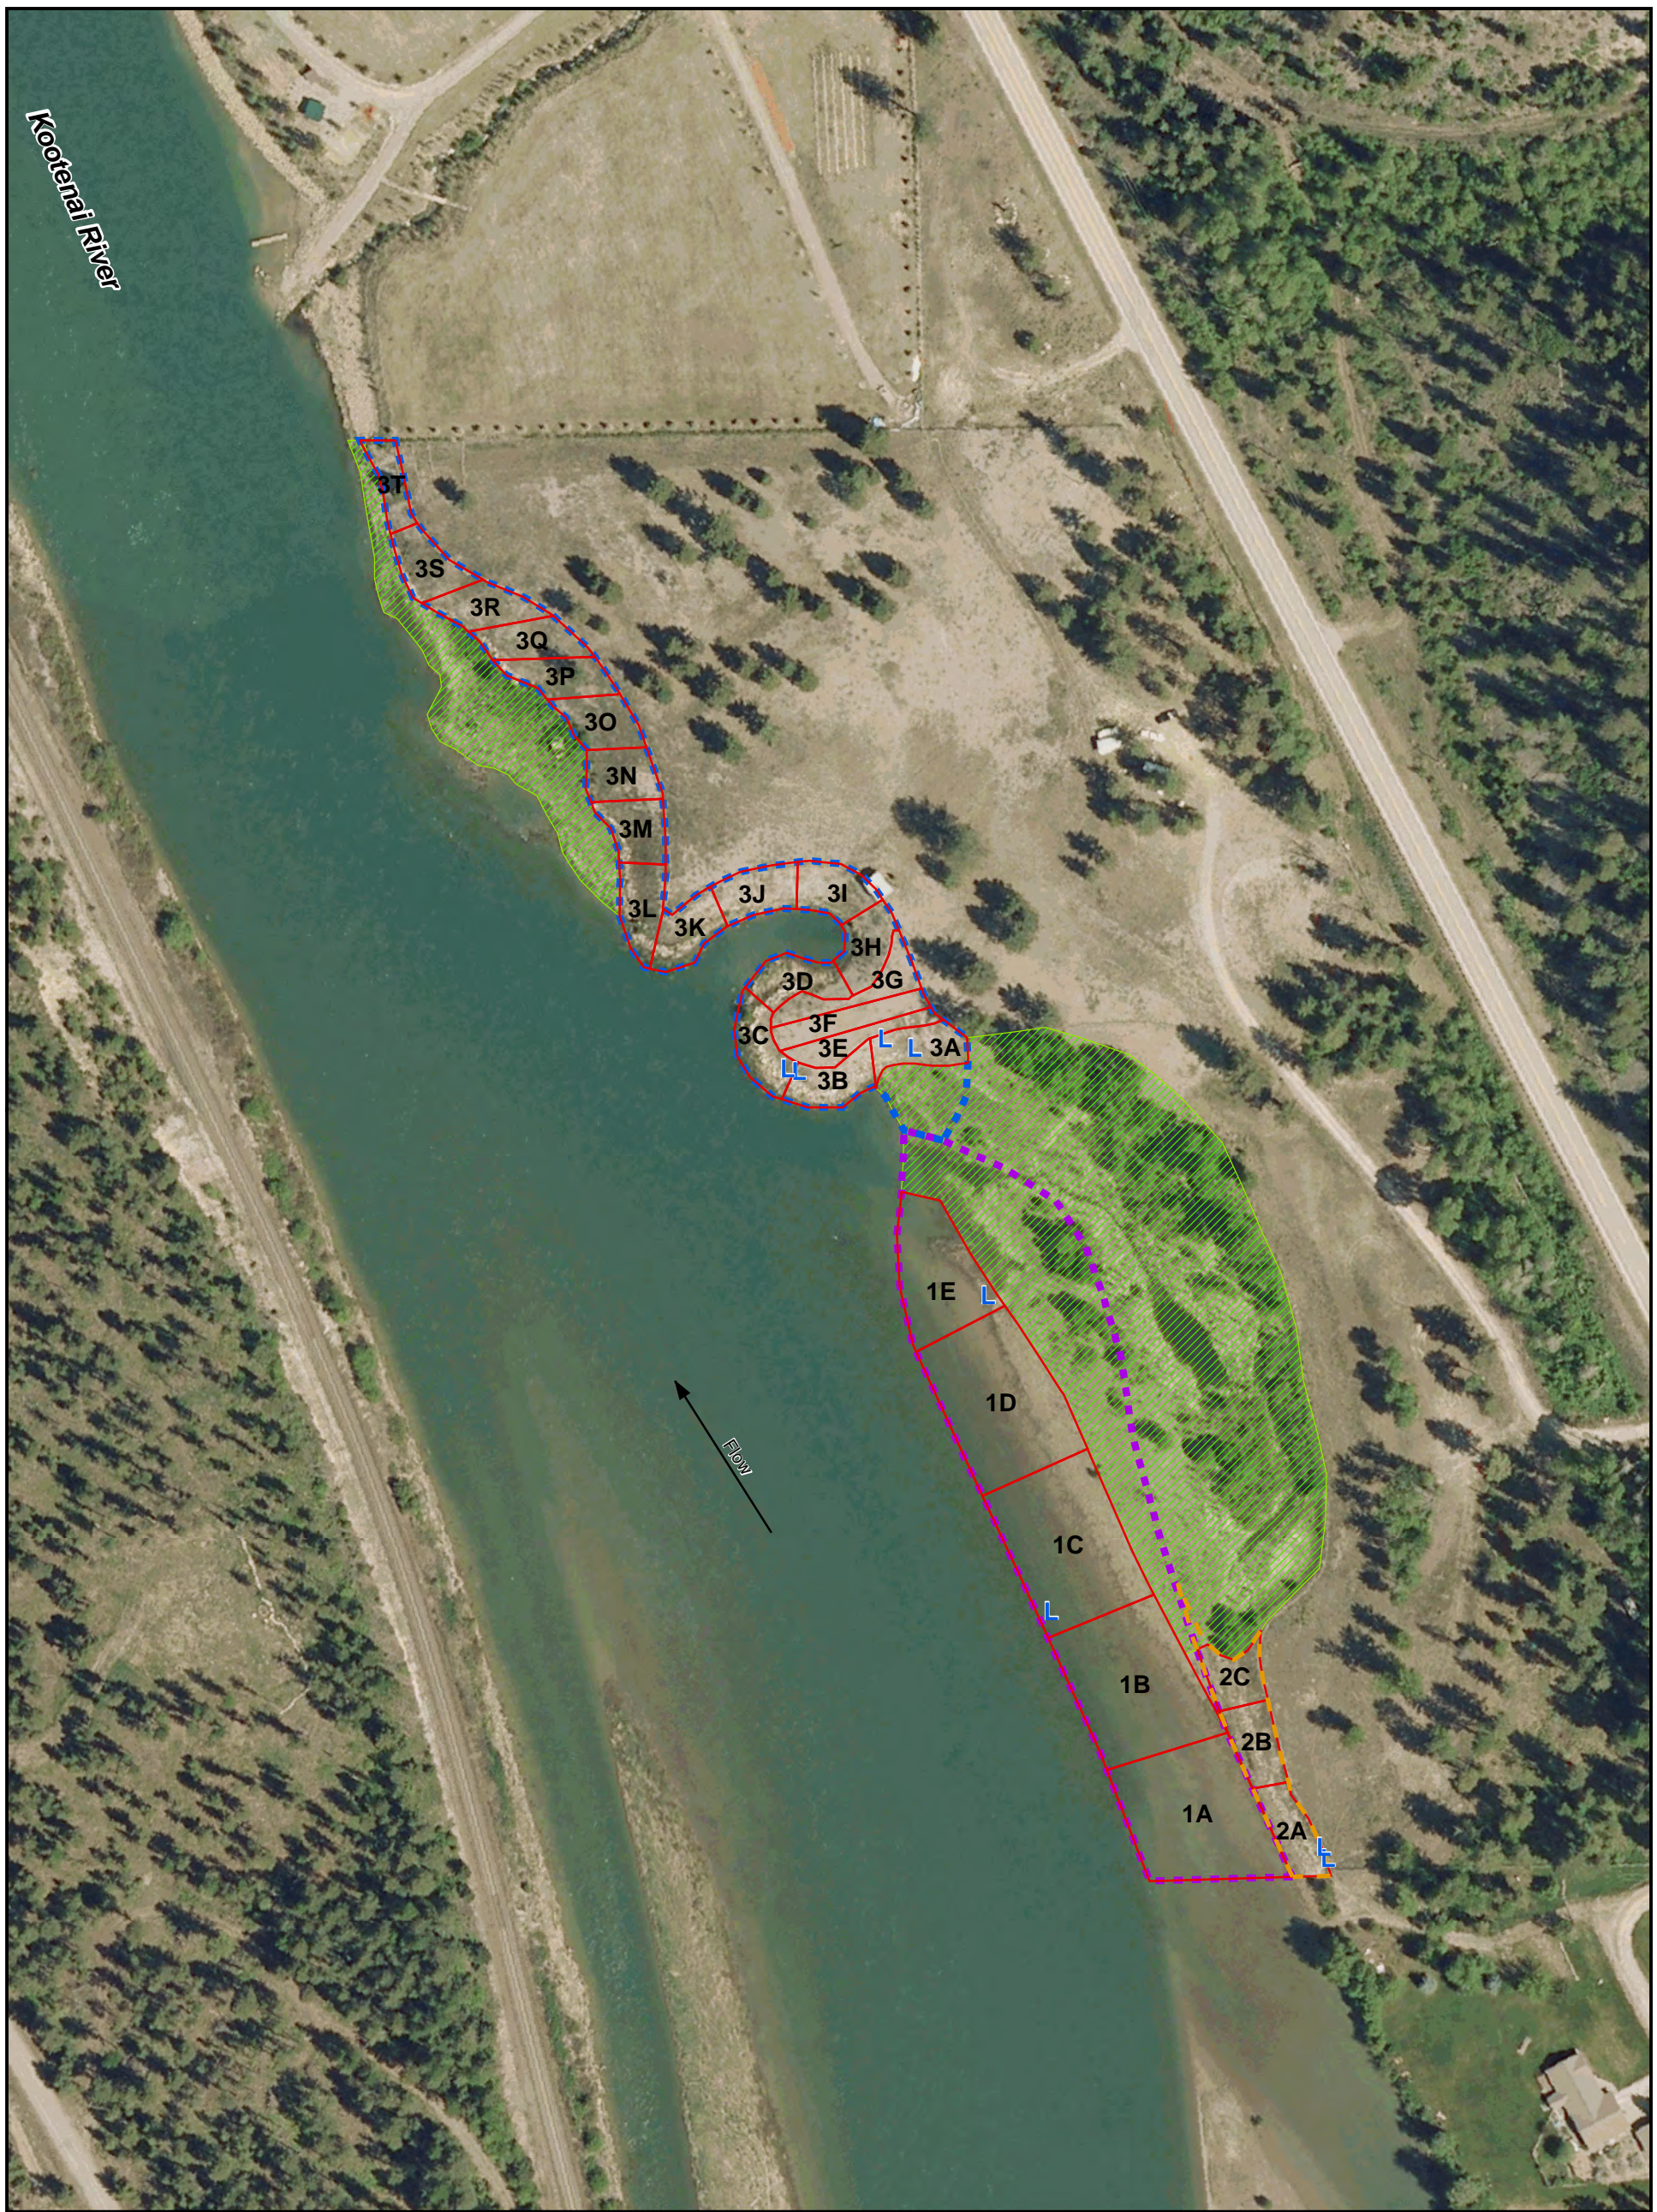
All samples for this investigation were surface soil samples collected from 0 to 3 inches bgs. A total of 28 soil samples and two duplicate soil samples were collected on July 29 and 30, 2010. All five of the samples collected in Area 1 were ND for LA, however, one additional inspection point with low concentrations of vermiculite was observed during sampling. All three of the samples collected in Area 2 were ND for LA. One of the 20 samples collected in Area 3 contained a trace (TR) concentration of LA; the remaining 19 samples were ND for LA. Sample and visual inspection results are provided in Table 3-1. The location of these results is shown on Figure 3-3.
